CERTIFIED MAIL NO. 7160 3901 9842 1746 8161
NOTICE OF BREACH OF LEASE AGREEMENT AND RECLAMATION REQUIRED

RE: ML 44815-Clay
Time CD #9010455
DOGM Permit #S/055/006

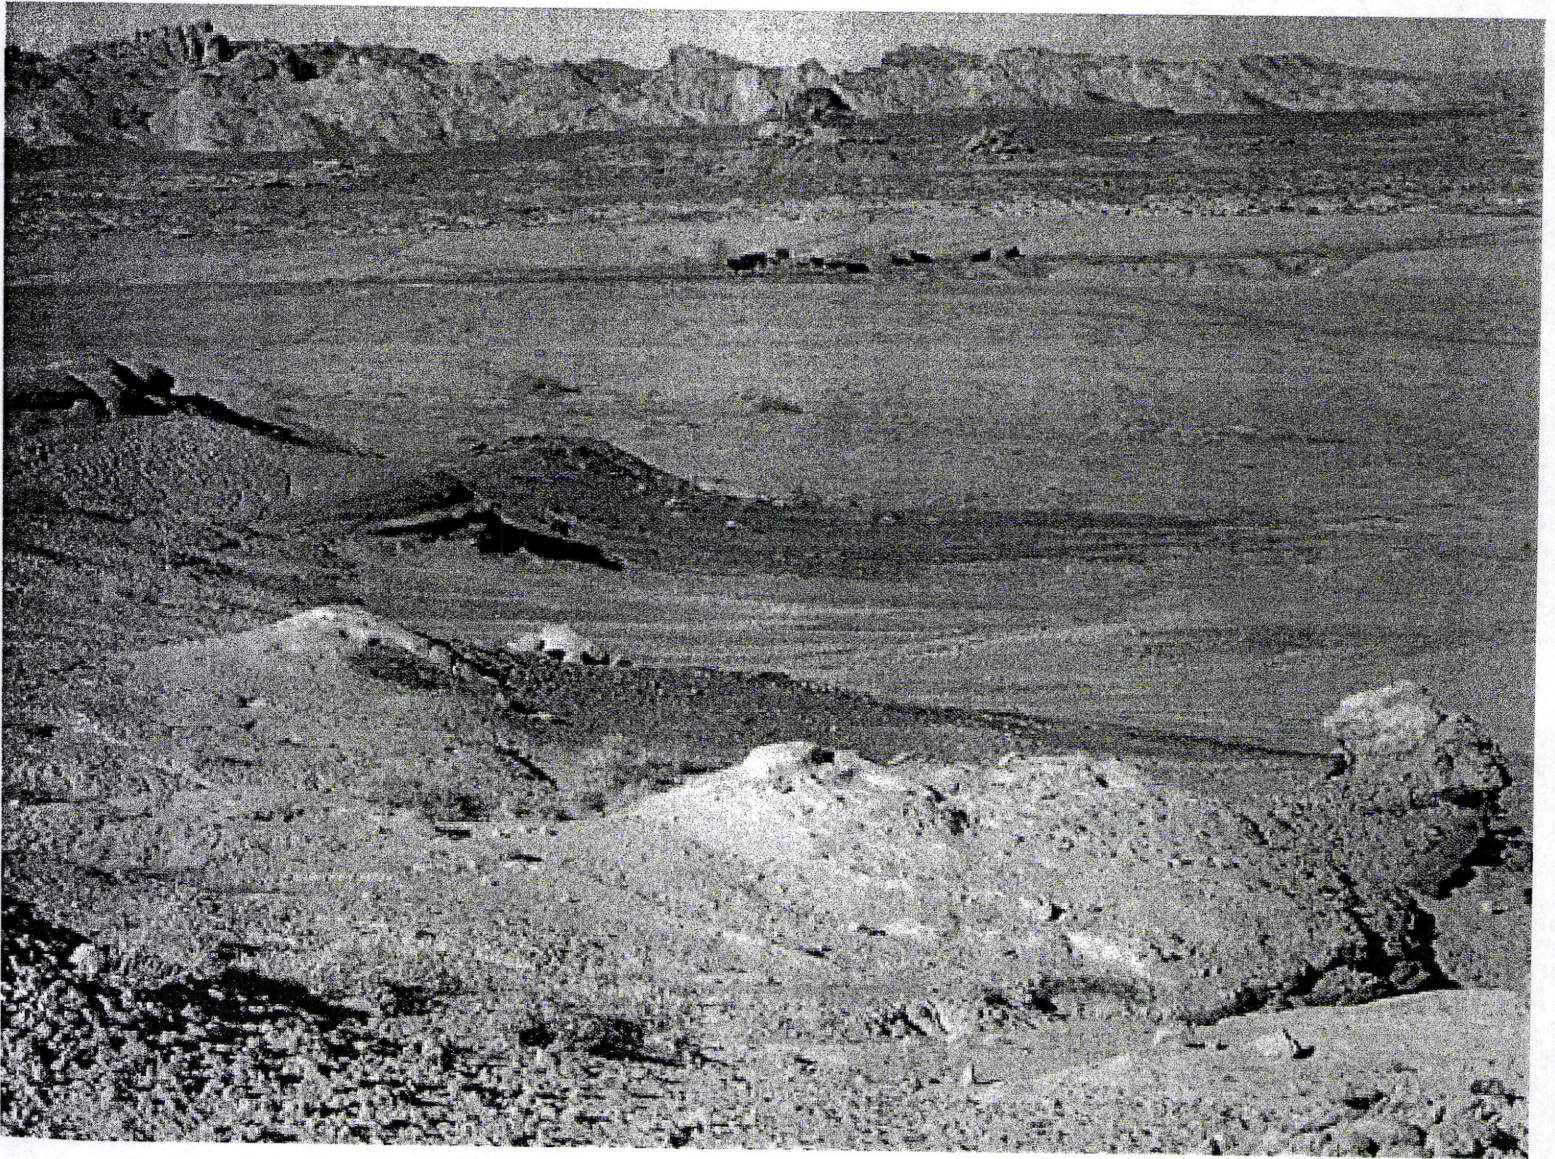
ML 44815 Clay

OK

Looking northwest across an additional disturbance that appears to have been recontoured. The disturbance in the other photo is to the left of this photo.

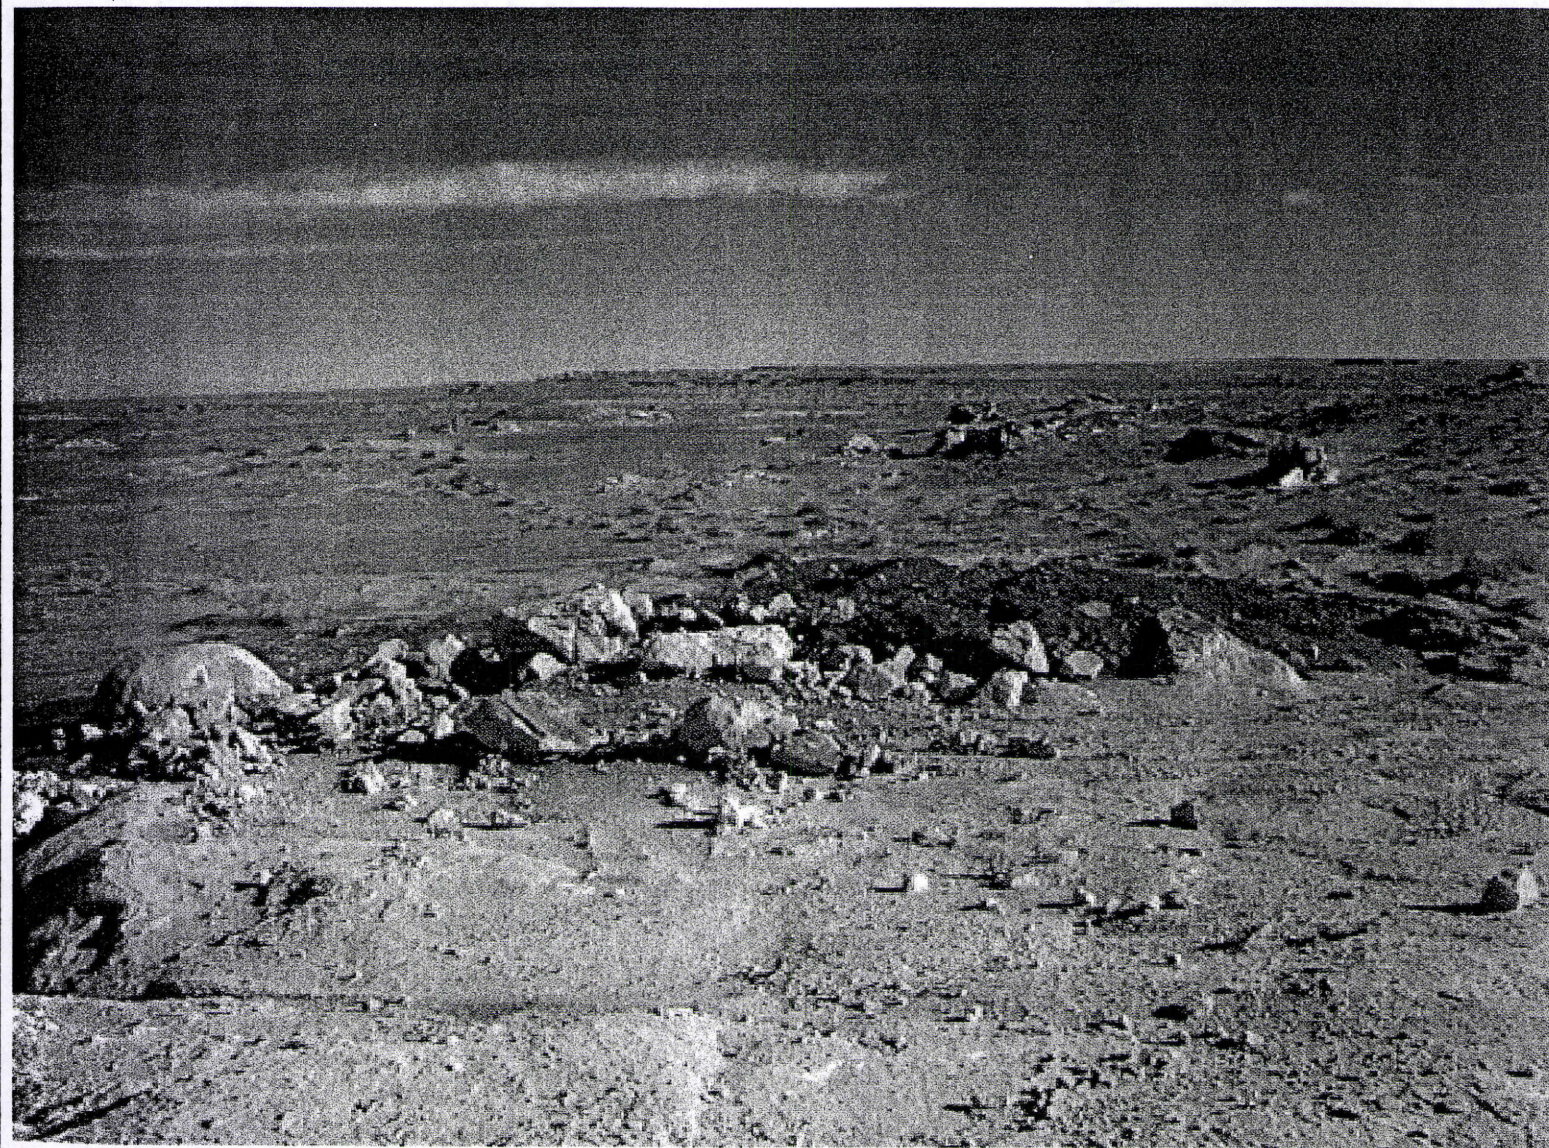
ML 44815

Some of the mining disturbances on the permitted lands have already been reclaimed, however, the site disturbed furthest to the east within the SW4SW4 & W2SE4SW4 block the leasehold is not satisfactorily reclaimed (please see enclosed picture). In order to satisfactorily reclaim this site the following work must be performed.

NOT OK

Looking southwest onto an excavation that has not been reclaimed.
The disturbed area is small, approximately 600 Sq Ft, and was difficult to find in the field.

1. Remove the excavated sandstone boulders that are lying in and upon the excavated humic shale material and place the boulders in a temporary stockpile.
2. Regrade the excavated humic shale material in place to match the adjacent natural land contours.
3. Cover the regraded humic shale materials with sand and clay to a thickness of approximately One Foot. (You may scrape-up some sand and clay from the surrounding lands within the leasehold to use as cover materials provided that you also regrade all such areas as may be disturbed).
4. Redistribute the sandstone boulders in the temporary stockpile. Placing them over the regraded and covered humic shale materials.
